ULTRASONIC PLY-BY-PLY DETECTION OF MATRIX CRACKS IN
LAMINATED COMPOSITES

A Thesis

Major Subject: Aerospace Engineering

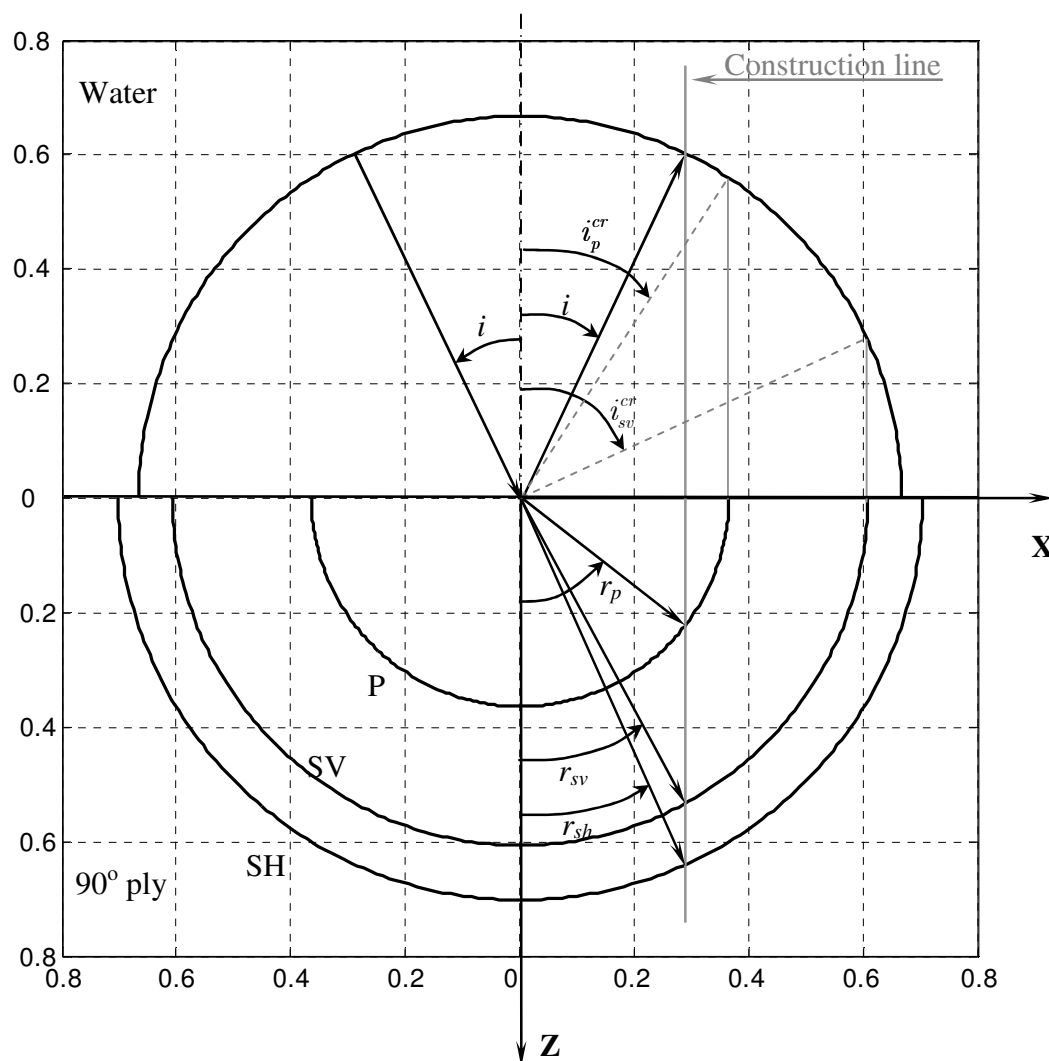
Fig. A-9 Slowness diagram for a water/90° ply system showing incident, reflected and transmitted waves. Values are in units of s/mm.

The slowness diagram representation for waves propagating from water to a 0° ply is shown in Fig. A-9. Water is modeled as an isotropic, non-viscous fluid and hence can support only a P-wave. As a result the slowness diagram for water shows only one circular profile with radius (S_w) given by

where v_w is the speed of longitudinal waves in water. The slowness diagram for the 90° ply shows three curves for the P, SV and SH waves respectively. The angles of incidence, reflection and refraction will be measured from the normal to the interface. Suppose the P-wave is incident at an angle i from the vertical, then at the interface, there exists a P-wave reflected at an angle i and three possible transmitted waves in the 0° ply: P, SV and SH at angles of refraction r_p , r_{sv} and r_{sh} respectively. The relation between the angle of incidence and angles of refraction for the three waves is governed by Snell's law as:

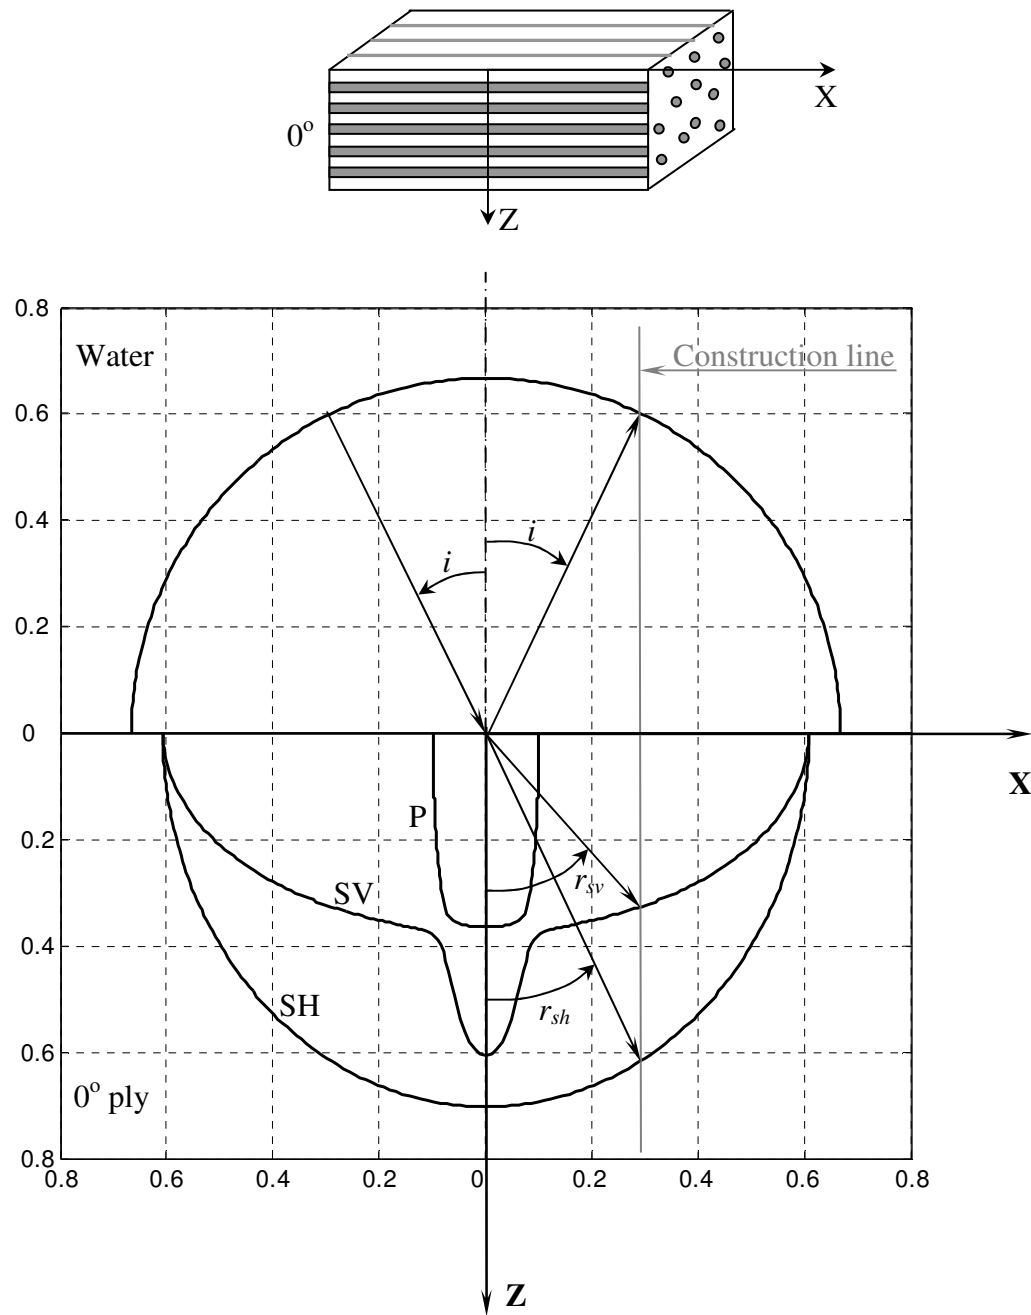
Fig. A-10 Slowness diagram for a water/0° ply system showing incident, reflected and transmitted waves at 25° angle of incidence. Values are in units of s/mm.

Similar analysis was conducted for a P-wave originating in water and incident on 45° and 90° plies. The slowness diagrams for the 0° , 45° and 90° when the angle of incidence is $i=25^\circ$ are shown in Fig. A-10, Fig A-11 and Fig. A-12 respectively. Important results from the analyses are listed in Table A-2. It is clear that when a P-wave from water is incident on a 0° ply or a 45° ply at 25° angle of incidence, the refracted P-

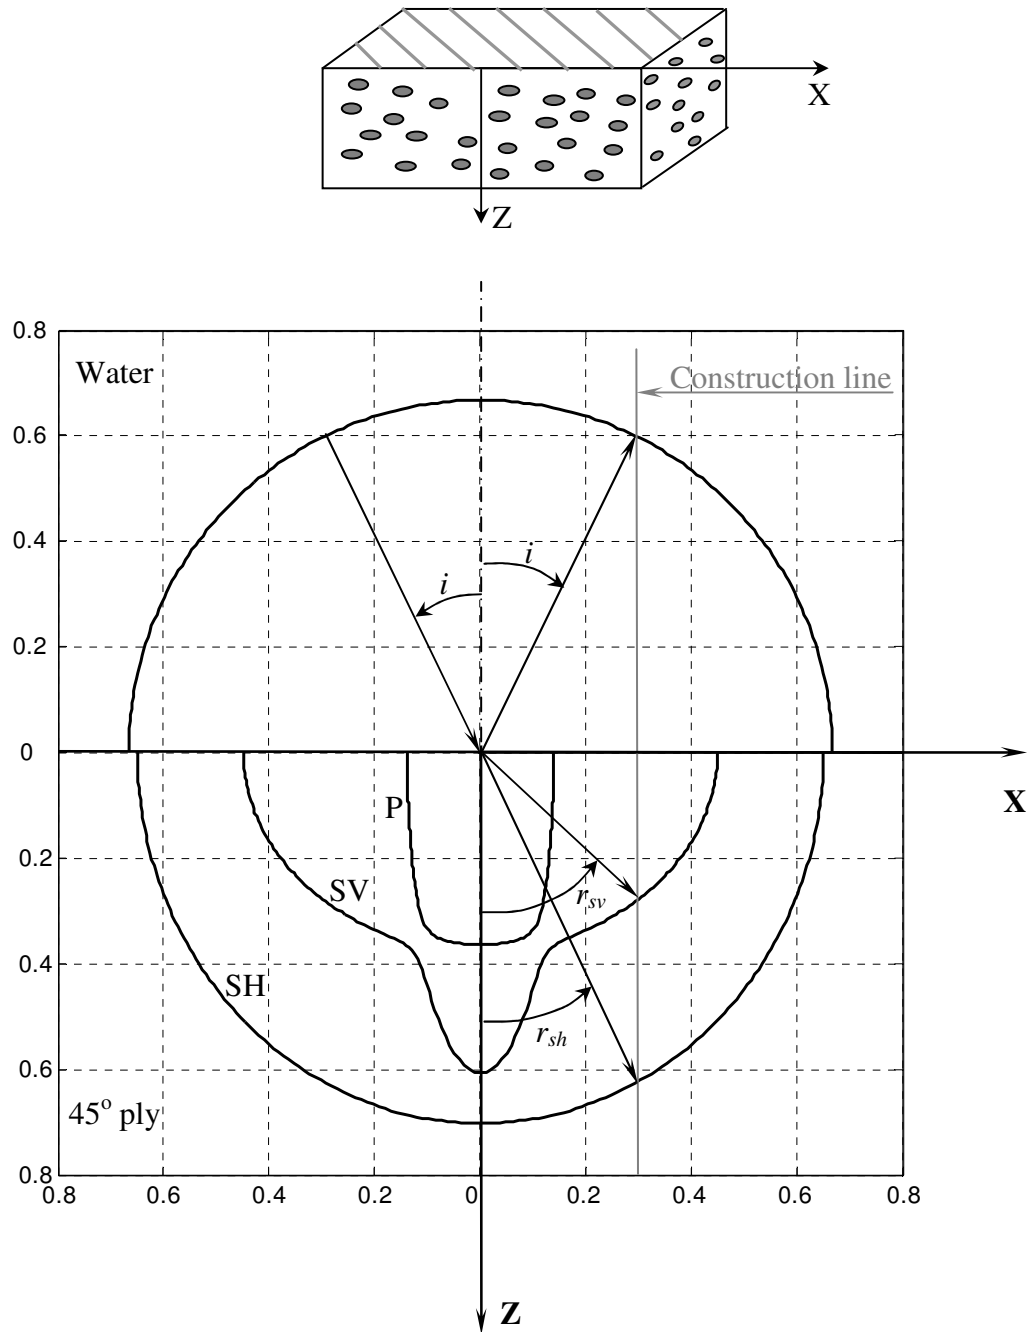
Fig. A-11 Slowness diagram for a water/45° ply system showing incident, reflected and transmitted waves at 25° angle of incidence. Values are in units of s/mm.

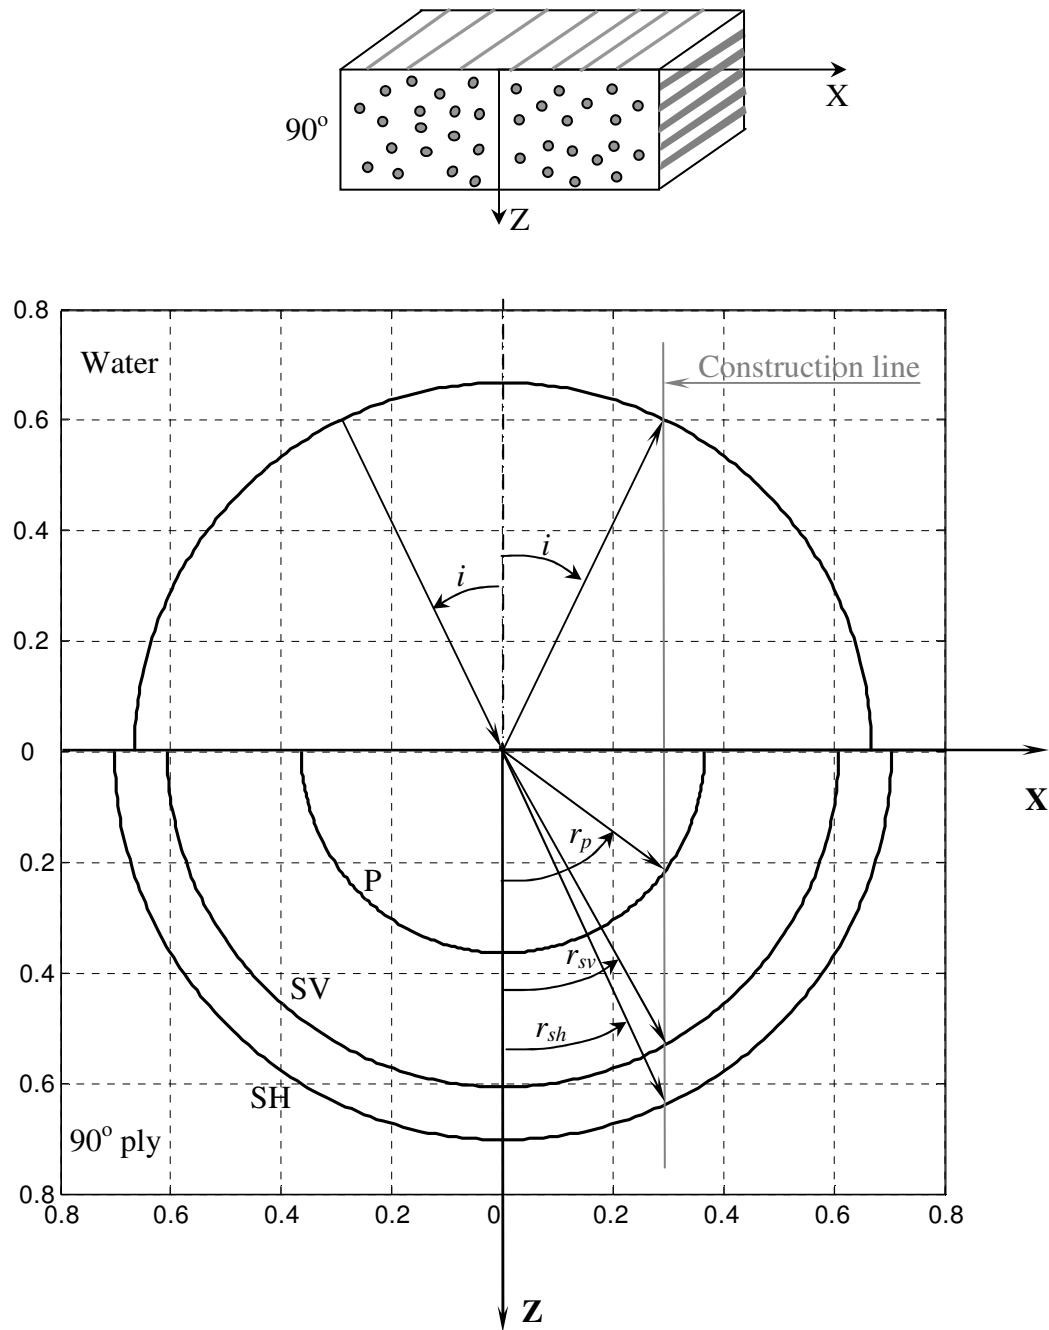
Fig. A-12 Slowness diagram for a water/90° ply system showing incident, reflected and transmitted waves at 25° angle of incidence. Values are in units of s/mm.
